Update on the temporary closure of the Salesforce Transit Center

May 8, 2019

Agenda

1. Progress on the Girder Remediation/Repair Effort
2. Progress on Confirming the Facility-Wide Validation
 - Facility-Wide Structural Steel Review Update
 - Facility-Wide Review Update of Non-Structural Steel Items
3. Quality Inspection Report Overview

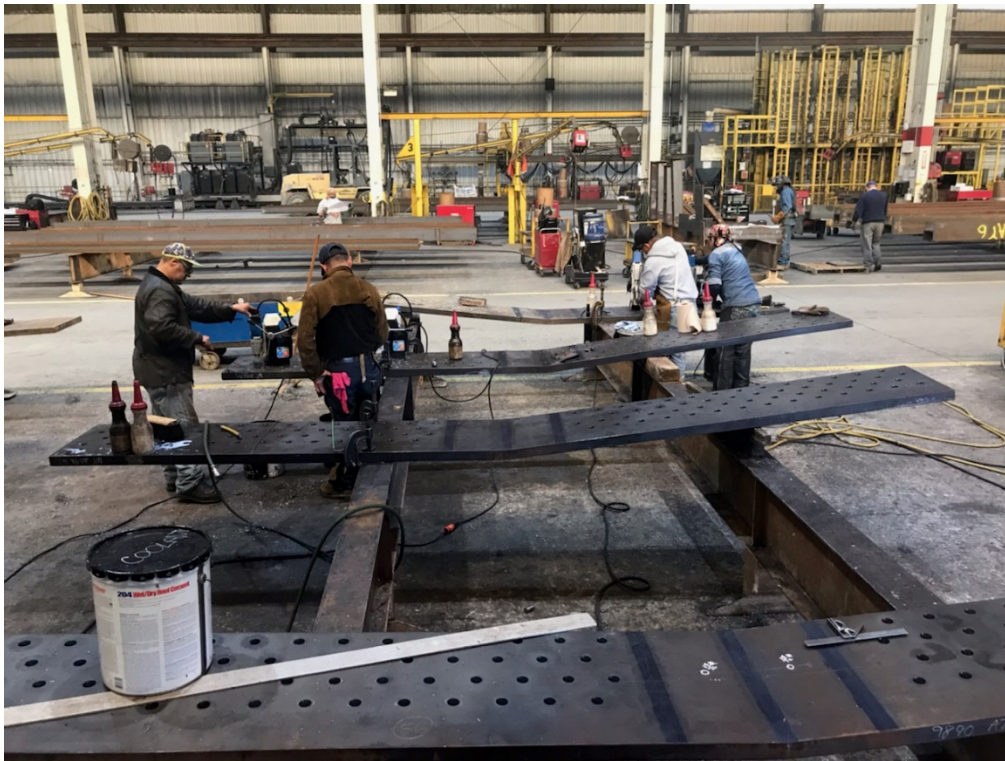
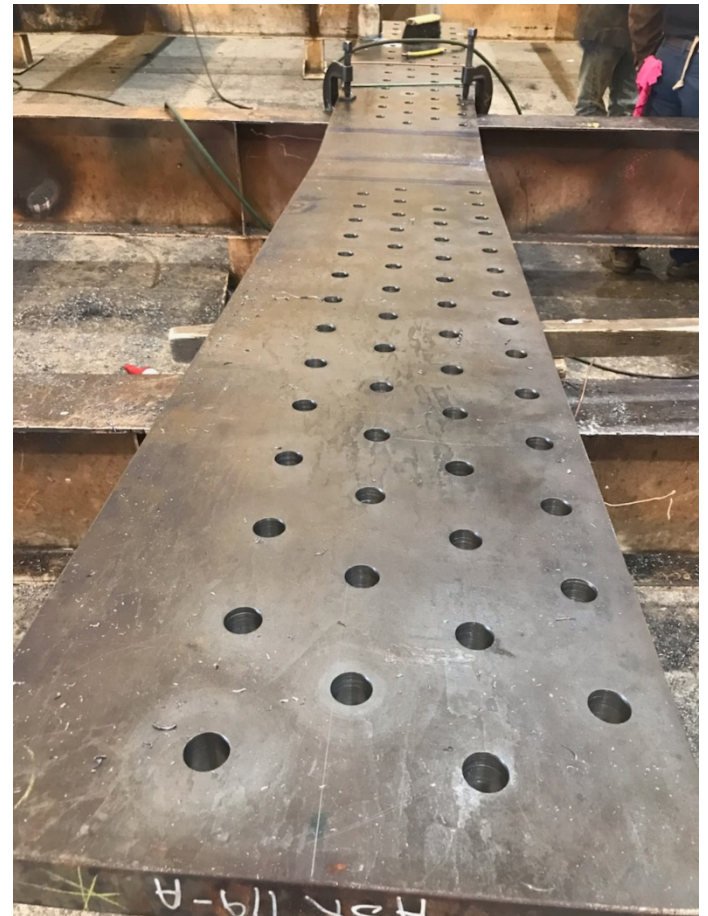
Preparation of the plate material.

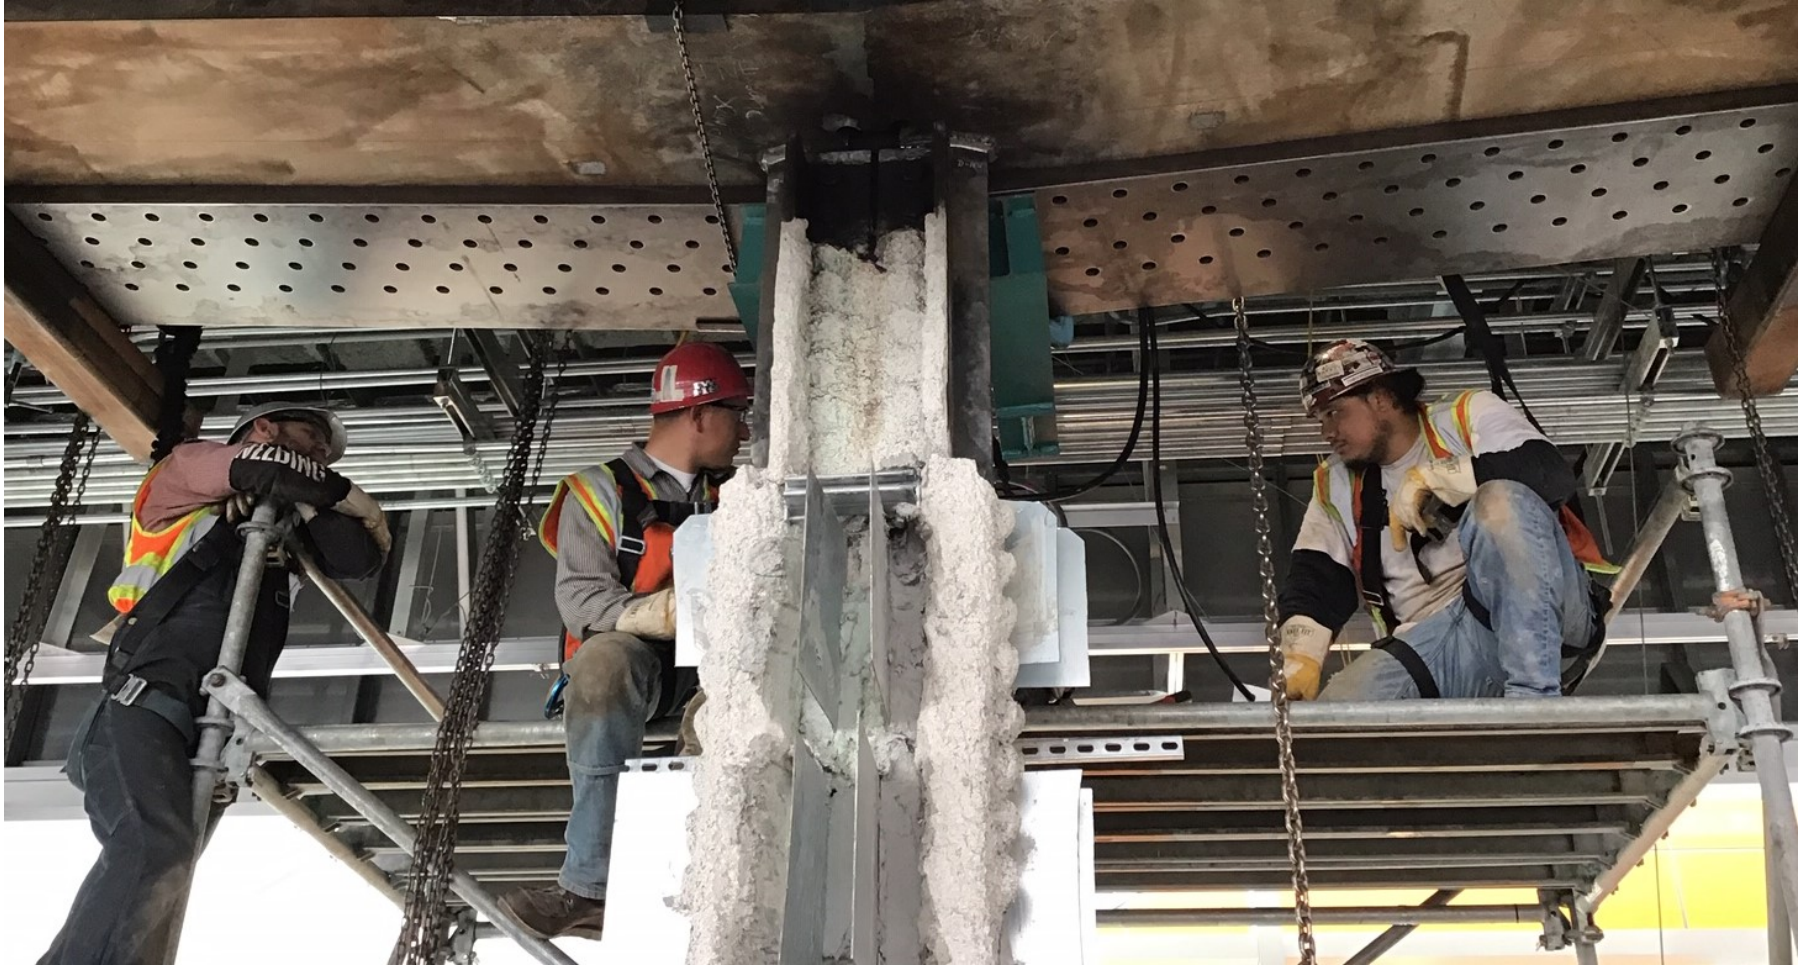
Plates installed onsite

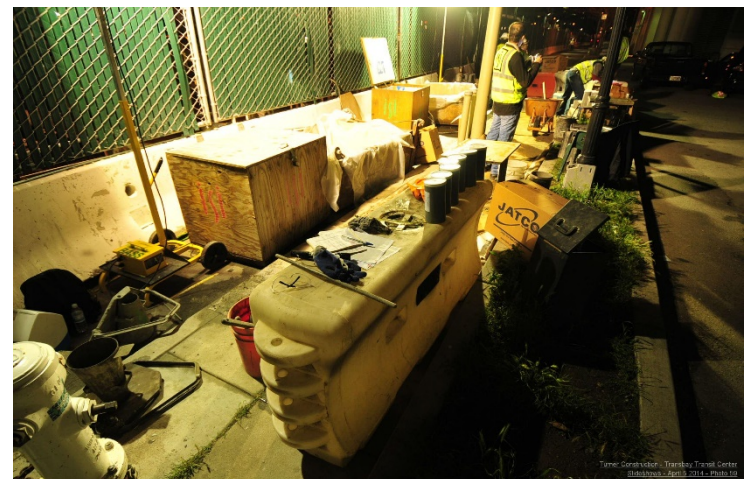
Concrete Placement Observation

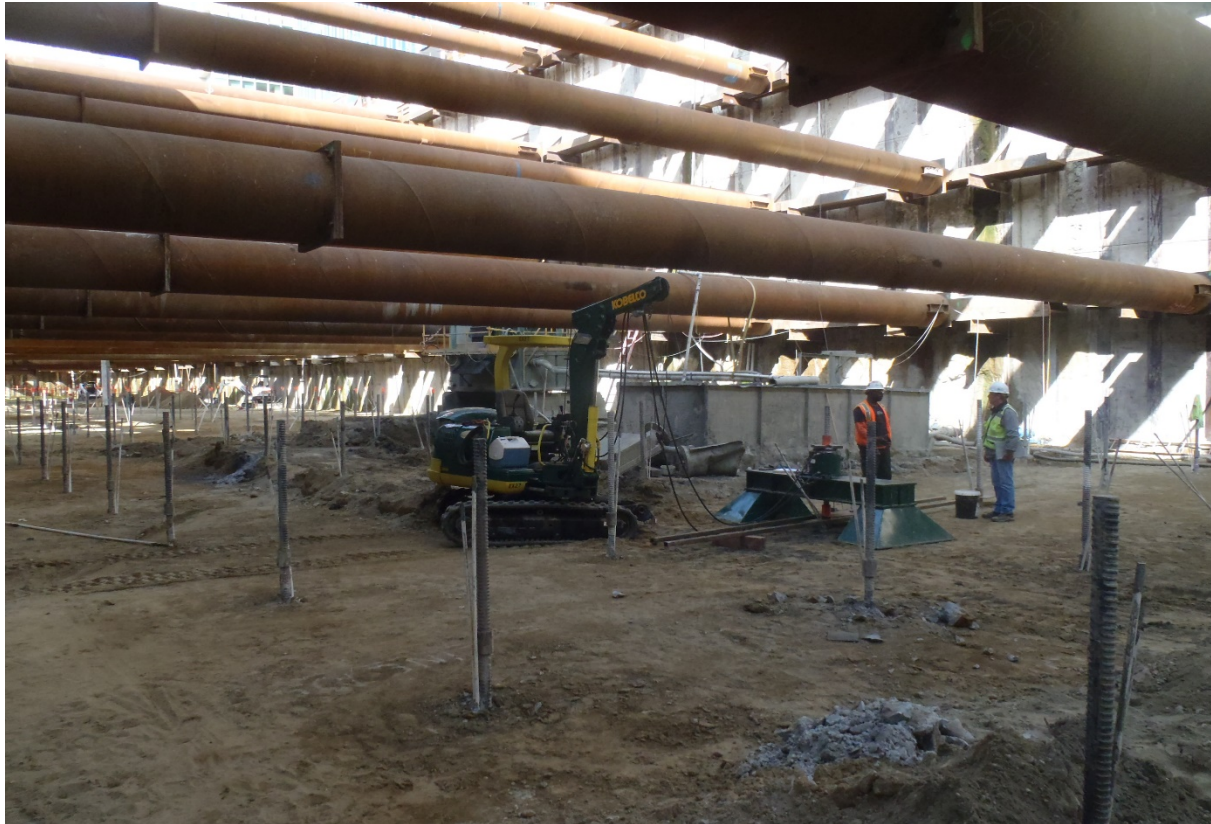
Micropile Testing

Micropile Pull Test Underway

- Verify equipment calibration - gauge & ram
- Perform a "pull" test on every micropile to 1.54X the design strength or 308 kips
- Displacement verification – less than 0.0825" in 10 minutes at 308kips
- Creep movement verification – less than 0.04" in 10 minutes; less than 0.08" in 6 to 60 minutes at 308kips

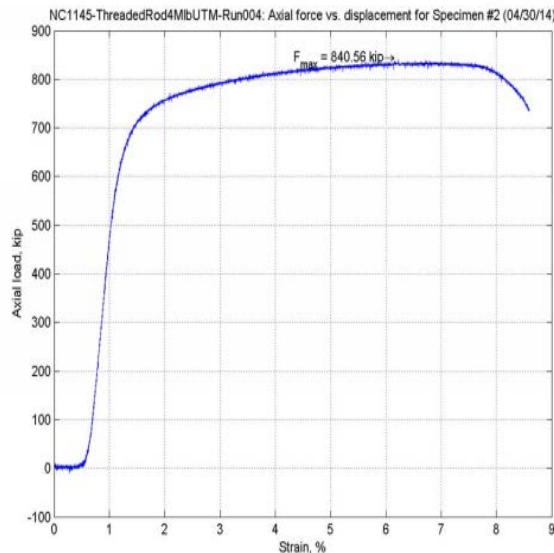
High Strength Bolt Lot Testing

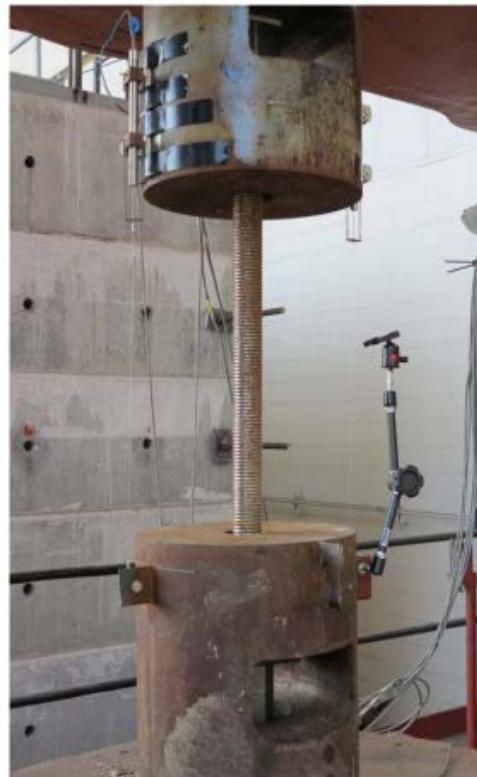
Strain testing to
design limits

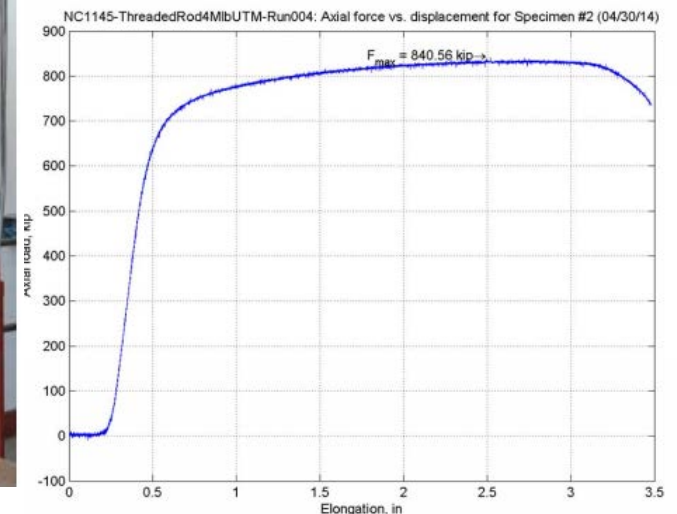
Testing Bolt Samples

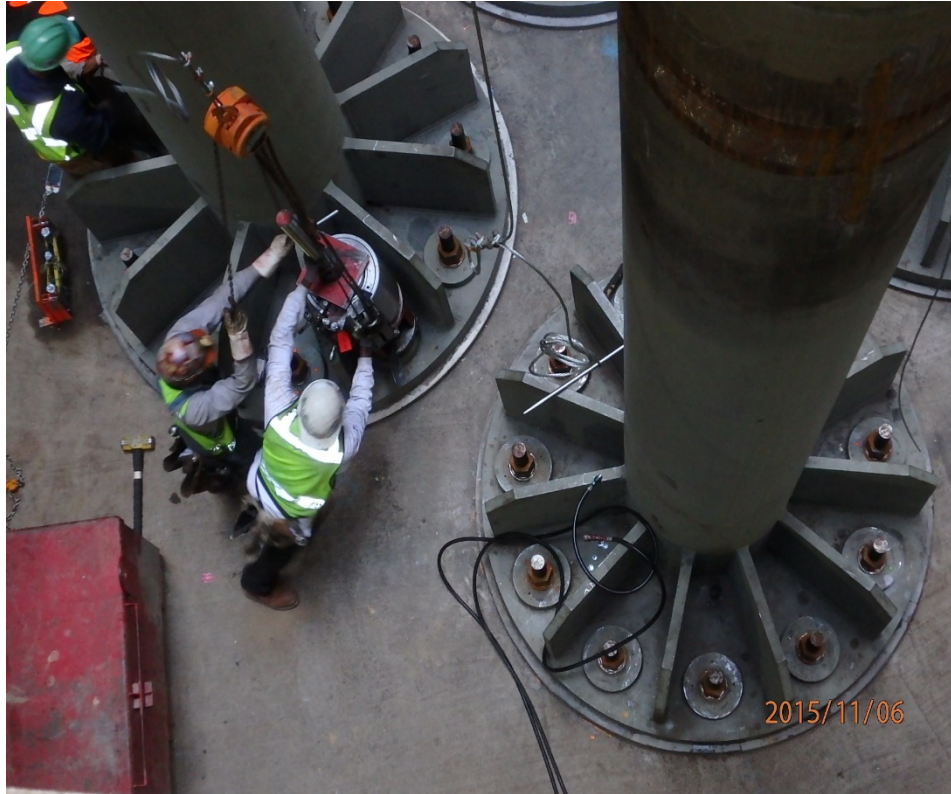
Bolt tensioning underway at Light Column

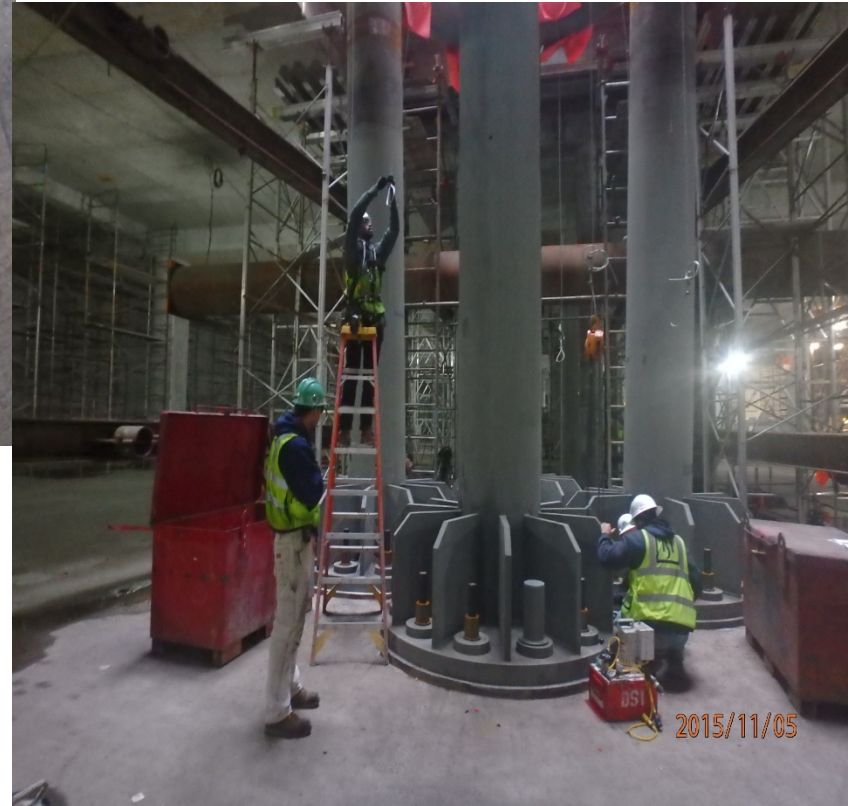
Bolt Tensioning Inspection

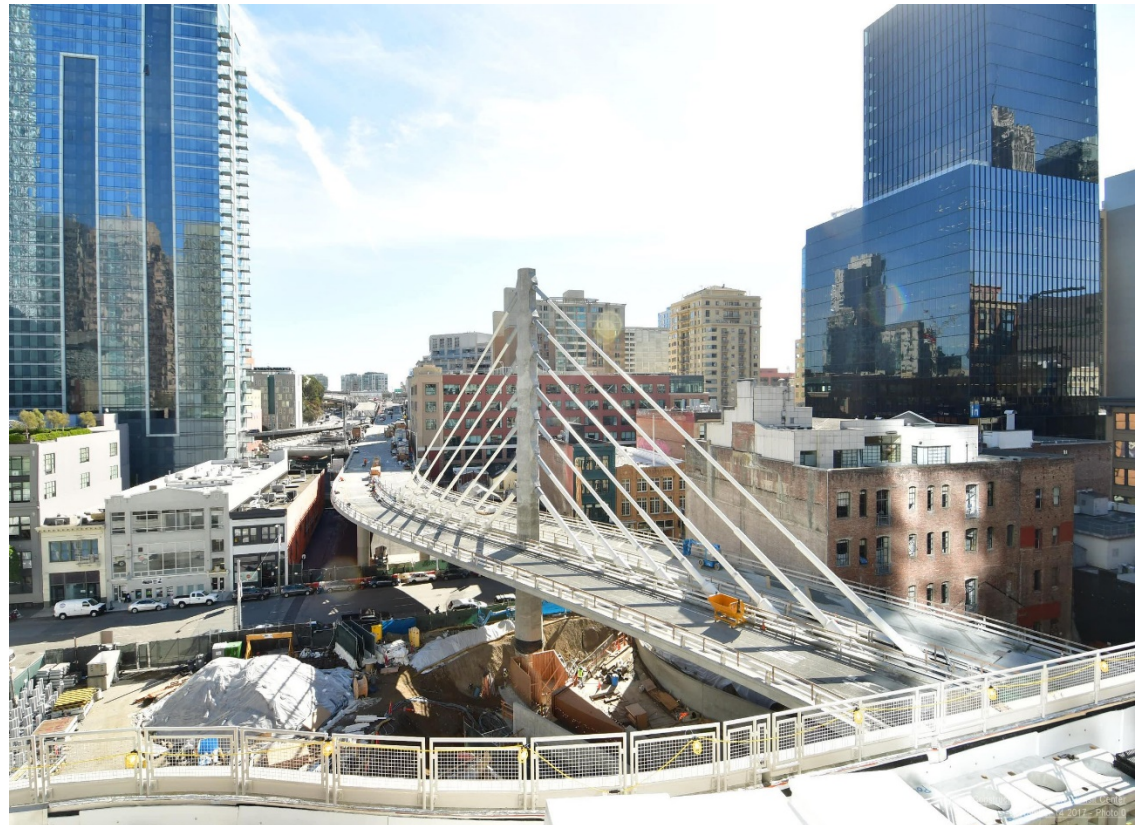
Total of 714 strands installed – all met design criteria

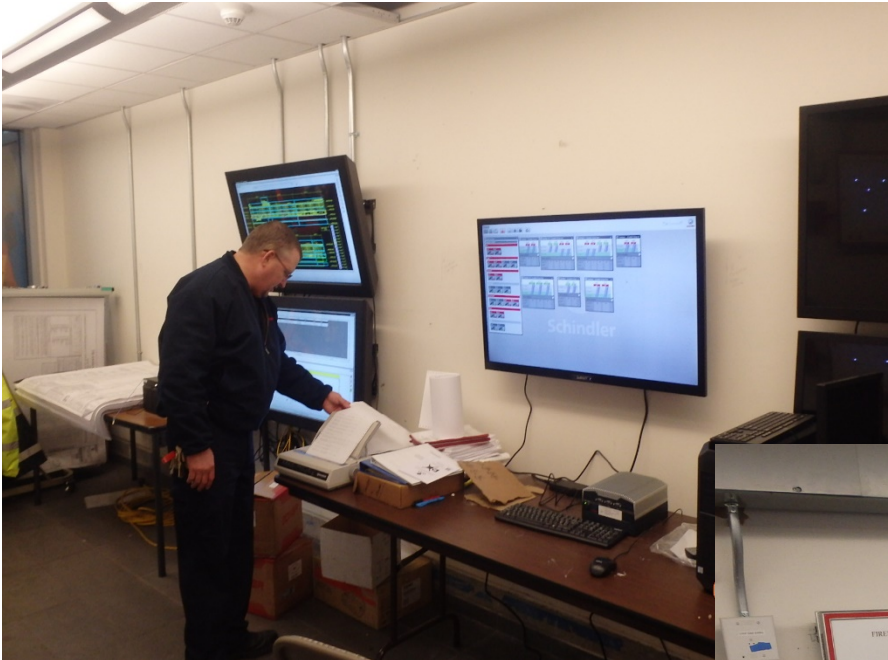
Transit Center Monitored 24 hours per day/ 7 days per week

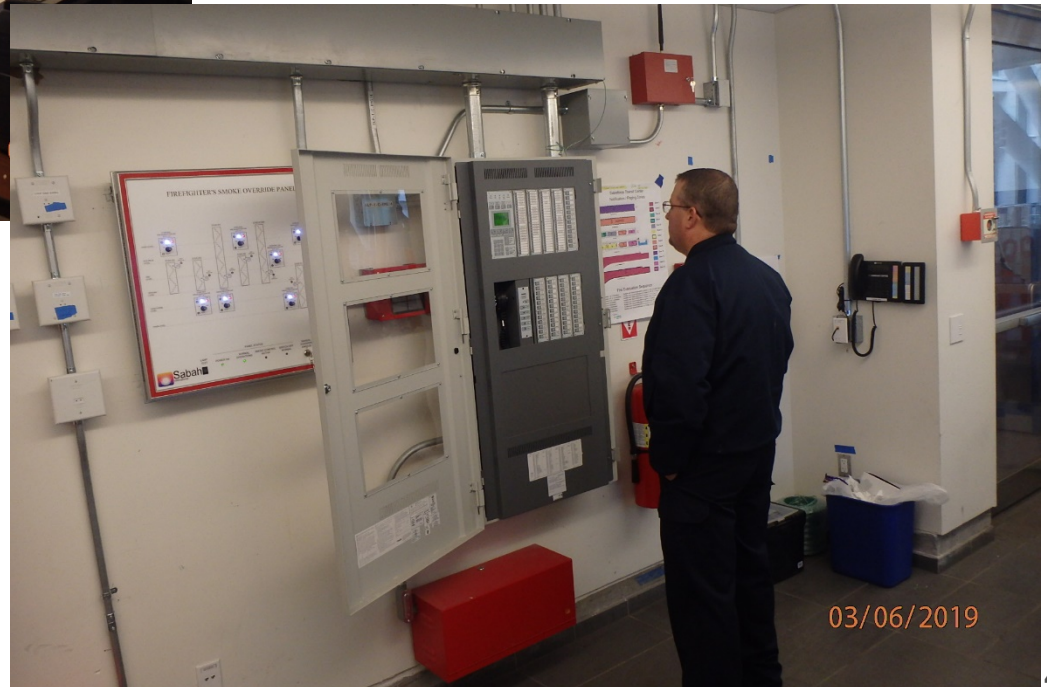
Building Fire Alarm Panel
